# **INDOOR AIR QUALITY ASSESSMENT**

**South Memorial Elementary School  
16 Maple Street Extension  
Peabody, MA**

Prepared by:  
Massachusetts Department of Public Health  
Bureau of Environmental Health  
Indoor Air Quality Program  
February 2023

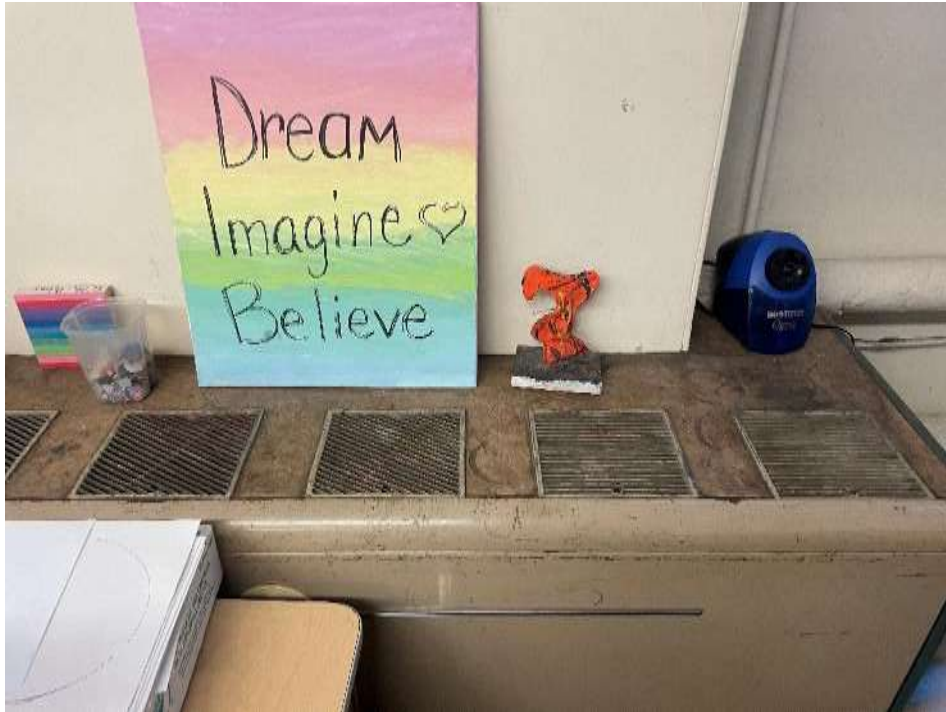
**Picture 1**

Fresh air in most rooms in the SMES is provided by unit ventilators (univents, Pictures 1 and 2). Most of the units appear to be original to the building, dating from the 1950s. Univents draw air from the outdoors through a fresh air intake located on the exterior wall of the building (Picture 3) and return air through an air intake located at the base of the unit. Fresh and return air are mixed, filtered, heated, and provided to rooms through an air diffuser located in the top of the unit (Figure 1). Thus, for proper operation, the top and front of the equipment should not be blocked. Some univents were blocked with furniture and items at the time of the assessment (Picture 1).

**Top of a classroom univent, note furniture in front**

3. Avoid blocking the front and sides of univents and exhaust vents with furniture and items.
4. Continue with regular filter changes for HVAC equipment using the best quality/highest MERV rated filters that can be used with current equipment. During filter changes, vacuum debris from univent cabinets.

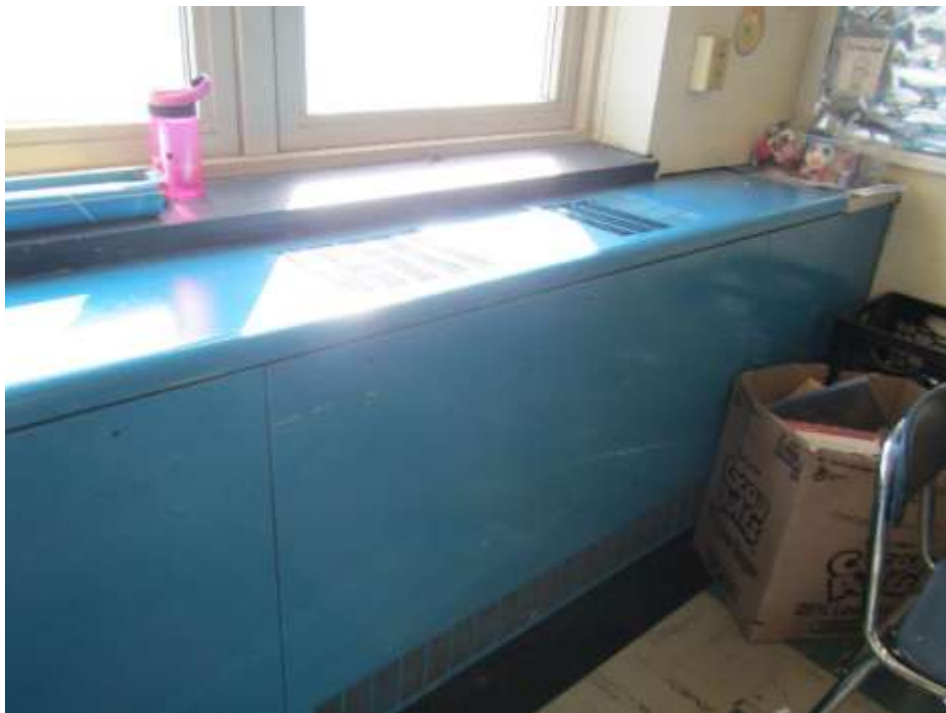
**Picture 2**

It is important to note that the univents examined are well past the end of their life cycle. Efficient function of equipment of this age (greater than 50 years old in the case of the original part of the building) is difficult to maintain, since compatible replacement parts are often unavailable. According to the American Society of Heating, Refrigeration, and Air-Conditioning Engineering (ASHRAE), the service life of this type of unit is 15-20 years, assuming routine maintenance of the equipment (ASHRAE, 1991).

**Classroom univent in the newer wing**

1. Contact an HVAC engineering firm for an assessment of the ventilation system's control system (e.g., controls, air intake louvers, thermostats), units and components. Based on the age, physical deterioration, and availability of parts for ventilation components, such an evaluation is necessary to determine the operability and feasibility of repairing/replacing the equipment.

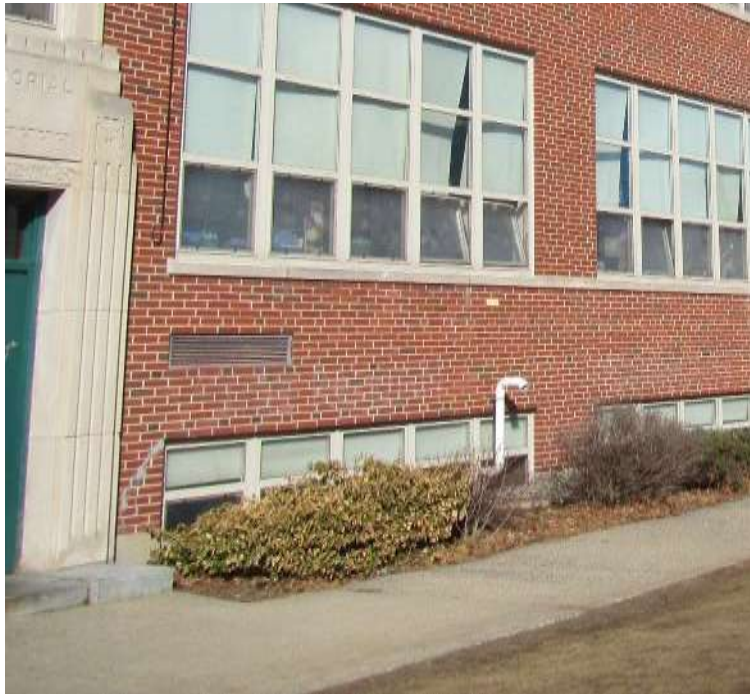
**Picture 3**

**Univent air intake on outside of building**

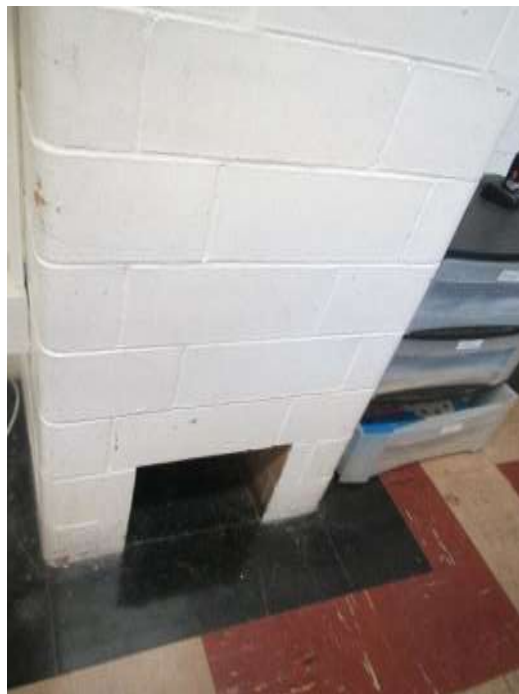
**Picture 4**

Mechanical exhaust ventilation in classrooms is provided by exhaust vents located along the hallway wall, sometimes located in “cubbies” (small insets into the wall) connected to fans on the roof (Picture 4). Some exhaust cubbies had items and furniture in front of them. Exhaust vents should also not be blocked. Many of the exhaust vents examined were either drawing

weakly or not at all. This includes exhaust vents in the student bathrooms on the second floor which had no draw of air. Exhaust vents should be checked for airflow periodically to ensure they are on, and the fans are operable, and repaired as needed. Exhaust vents are particularly necessary in restrooms to remove moisture and odors generated there.

**Classroom exhaust “cubby”**

1. Operate supply and exhaust ventilation continuously when the building is occupied. Check univents and exhaust vents during occupied periods to ensure they are on and operating. This includes exhaust vents in restrooms.

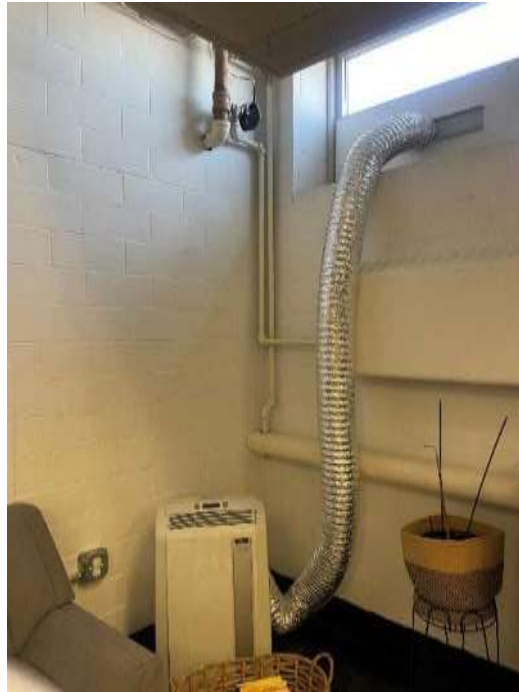
**Picture 5**

Portable air conditioners and window-mounted air conditioners were noted in a few places (Picture 5). Note that windows should not be opened while air conditioning is operating. An influx of hot, humid outside air that contacts surfaces chilled by air conditioning can lead to condensation. Alternating opening windows and use of portable air conditioners can provide air exchange while minimizing the chance of condensation.

**Portable air conditioner in the teacher’s lunchroom**

6. Avoid opening windows when air conditioning is operating in the room.
7. Maintain portable air conditioners, window air conditioners and air purifiers in accordance with manufacturer's instructions including cleaning.

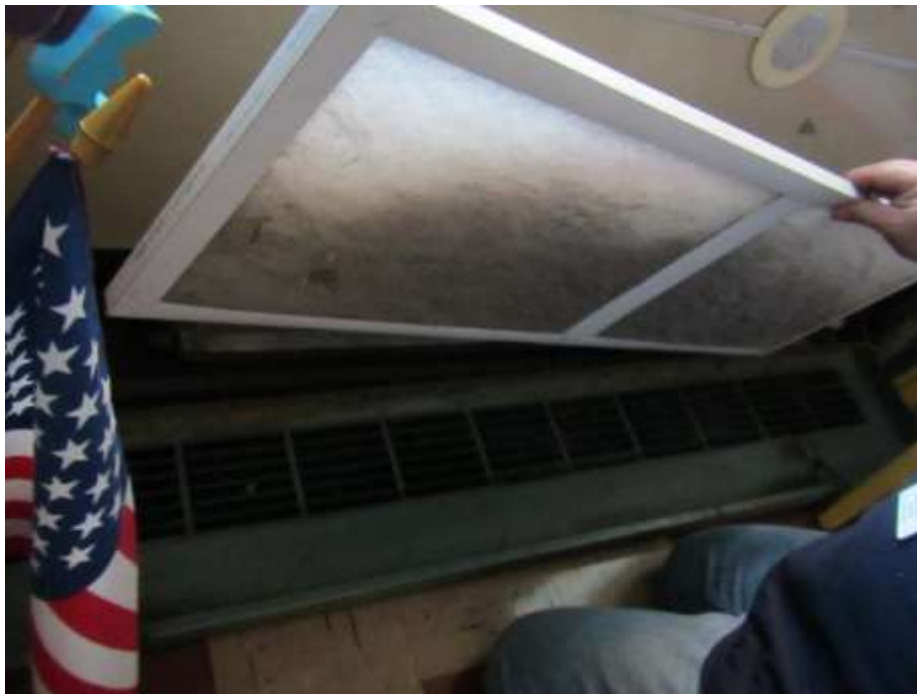
**Picture 6**

Univents have filters, which are reportedly changed 2-3 times a year during school breaks. One univent cabinet was opened and the filter examined (Picture 6). The filter was soiled and in need of changing; filter change was planned for school break the week after the visit. The

univent cabinet also needs to be vacuumed out to remove accumulated debris. Note that this filter appears to be is of a low Minimum Efficiency Rating Value (MERV). The MDPH IAQ program recommends a MERV of 8 or higher if the equipment can handle the pressure reductions caused by more restrictive filters.

**Soiled univent filter**

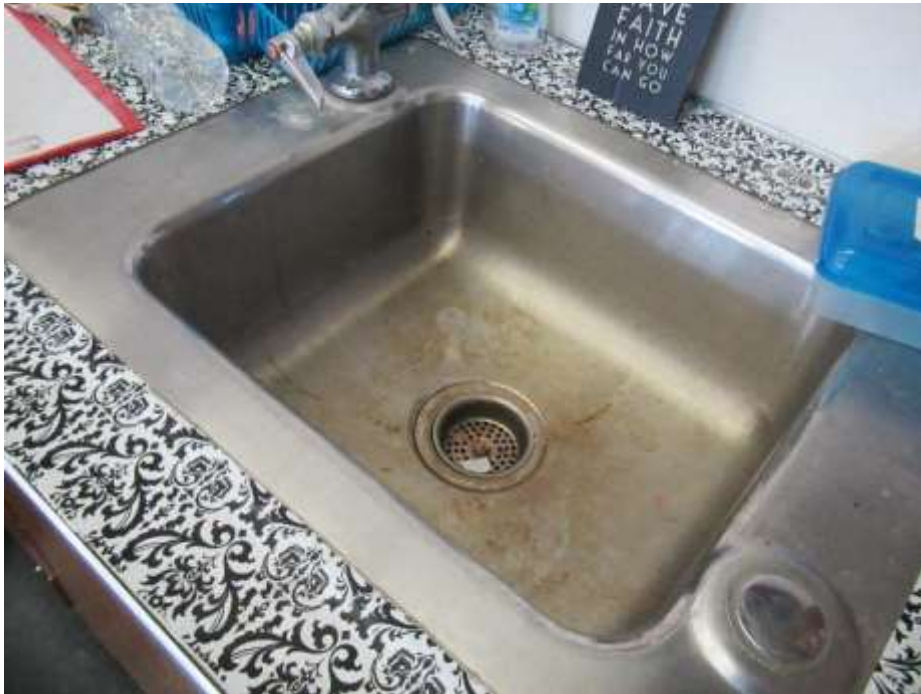
**Picture 7**

During the visit over the summer, facility staff reported that many of the sinks found in classrooms are unused or have been turned off. Plumbing that is not needed should be properly abandoned so it doesn't become a source of leaks. Also, drains attached to unused plumbing need to be properly sealed or wetted periodically to avoid dry drain traps. If the P-trap seals on plumbing become dry, sewer gases can enter occupied spaces. Many of the sink countertops and cabinets were in poor condition, or had been repaired using contact paper, strips of wood, and other materials (Picture 7). Since the area around a sink is a moist environment, water-resistant materials should be used for repairs.

**Sink countertop repaired with contact paper**

14. Ensure repairs to sink cabinets are made using water-resistant non-porous materials.
15. Ensure plants are well-maintained and not overwatered. Avoid placing plants on or in the airstream of univents.

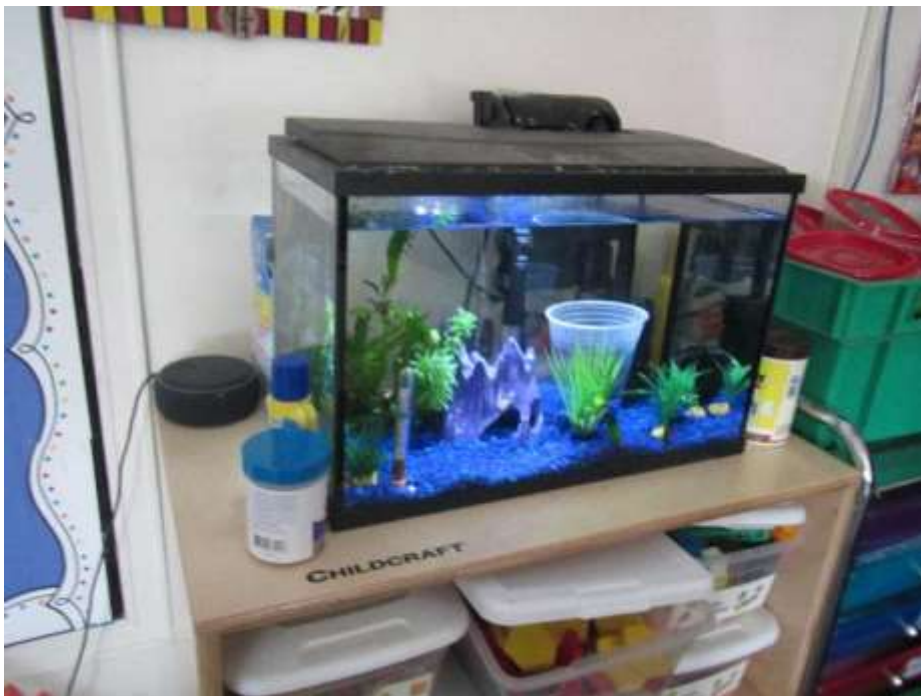
**Picture 8**

Aquariums were noted in some areas (Picture 8). Aquariums, terrariums, and similar items should be kept clean to prevent odors and microbial growth. If any indoor plants are present, they should be well maintained and not overwatered to prevent water damage and pests. This includes plants used for science experiments. Plants, aquariums, terrariums, and other sources of odors should be kept away from the airstream of univents and other ventilation equipment.

**Aquarium in a classroom**

16. Ensure any aquariums, terrariums and similar items are kept clean.
17. Avoid storage of porous materials or large amounts of items under sinks.
18. Trim plants and bushes away from the building a minimum of five feet, especially near windows and univent intakes.

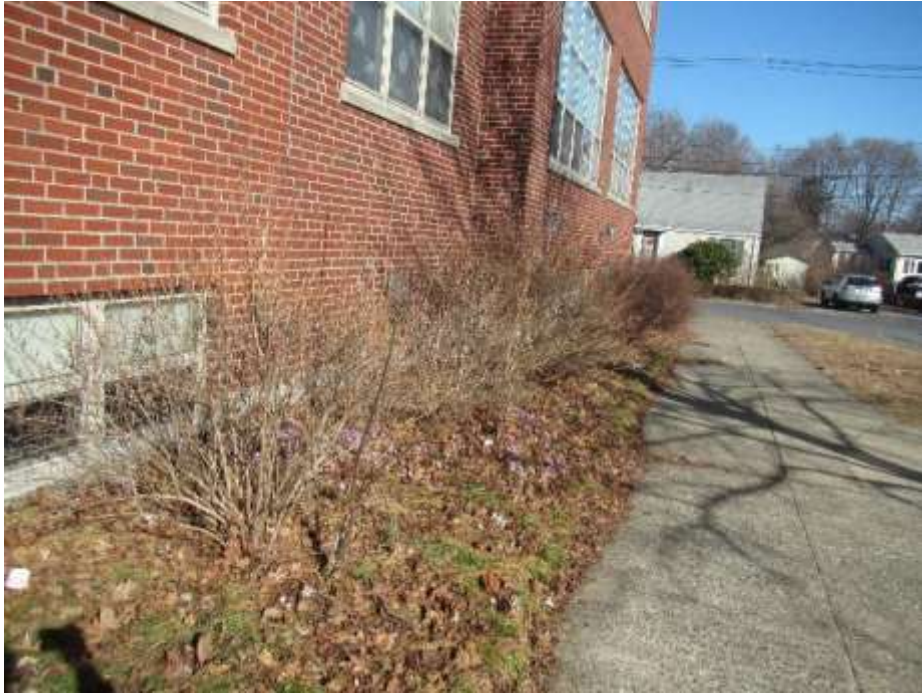
**Picture 9**

The exterior of the building was examined for potential sources of odors, pollutants, and water infiltration. Plants were noted close to the exterior of the building along one side (Picture 9). Plants can be a source of pollen, mold, and odors through univents or open windows. Plants can also hold moisture against the side of the building which increases deterioration of the building envelope. And plants can also be potential food and harborage for pests. Plants should be trimmed at least five feet from the exterior of the building.

**Bushes and trees near the building, including below univent air intakes**

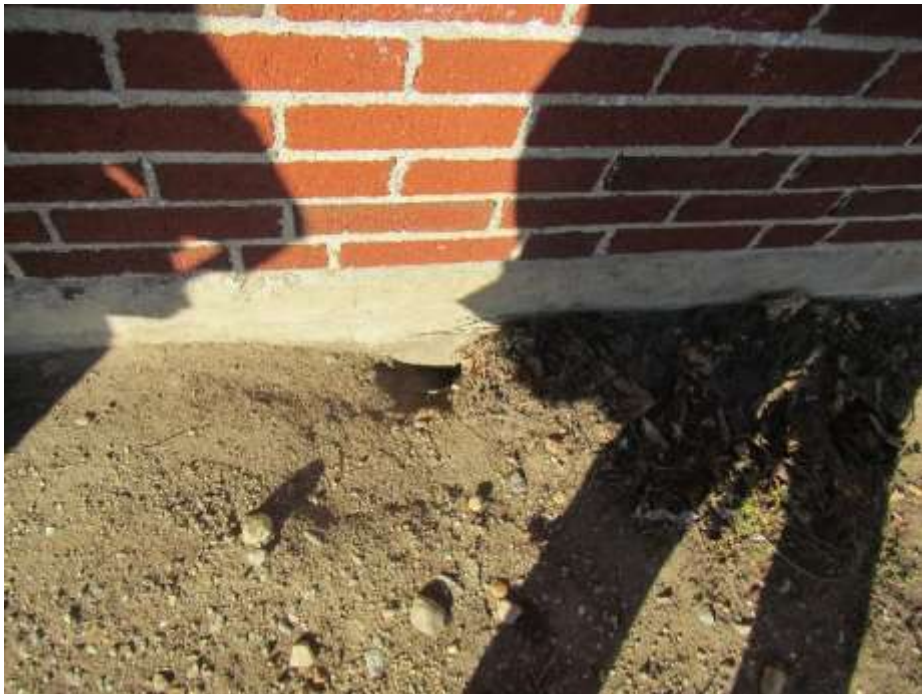
**Picture 10**

Holes in dirt next to the foundation appeared to be rat burrows (Picture 10). Rats can be a source of allergens in dander and urine. In addition, rat activity can damage buildings, leading to water infiltration.

**Holes in soil next to building that may be rat burrows**

20. Use the services of a licensed pest control company to monitor for and control rodents on the exterior of the building. Removal of exterior plants as recommended above will reduce harborages. The location of the suspected rat burrows is also near the dumpsters. Dumpsters should be kept in good condition with no holes and tight-fitting lids that are kept closed to deter rodents, and should be emptied frequently.
21. Avoid bringing in scented products (e.g., air fresheners, candles). Use only school-provided cleaning materials to avoid potential product interactions.

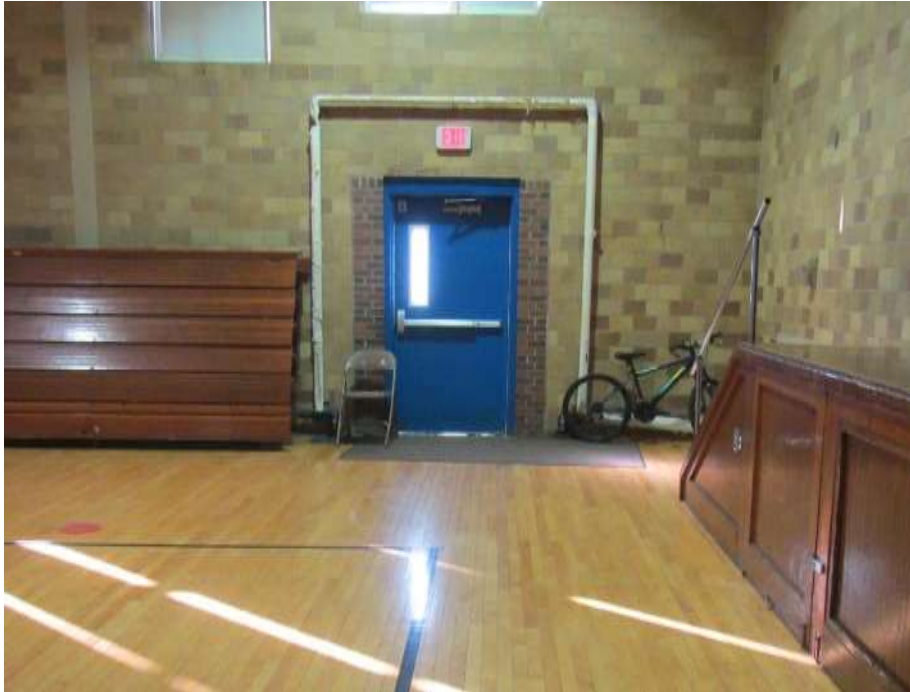
**Picture 11**

Light was visible beneath some exterior doors (Picture 11) indicating that the weather stripping is missing or worn out. Lack of weather stripping can allow unconditioned air, moisture, and pests into the building.

**Light visible beneath door to the outside**

19. Repair or replace weather stripping on doors where light is visible underneath.

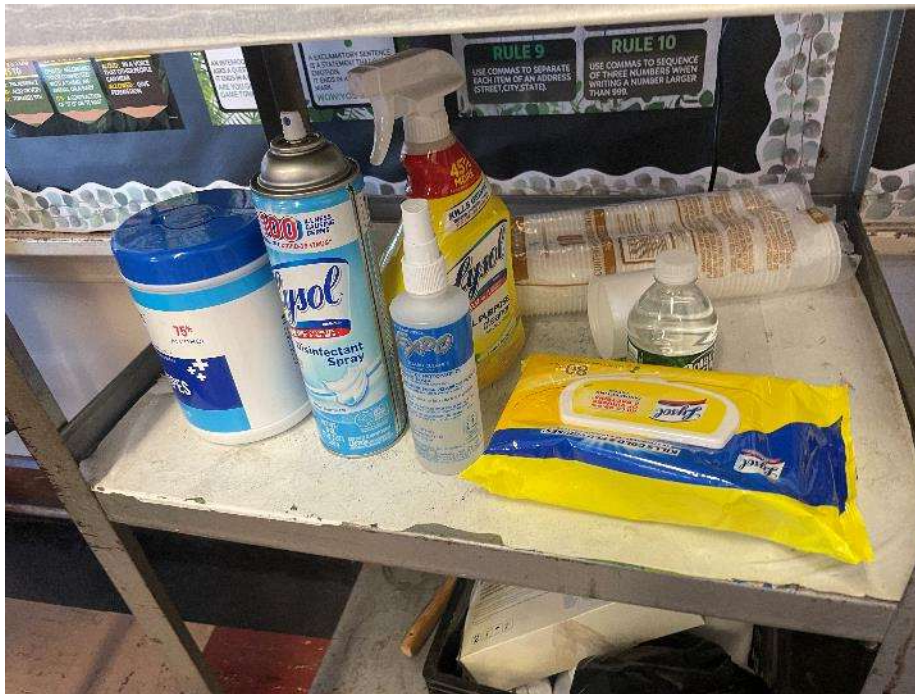
**Picture 12**

Exposure to low levels of total volatile organic compounds (TVOCs) may produce eye, nose, throat, and/or respiratory irritation in some sensitive individuals. BEH/IAQ staff examined spaces for products containing VOCs. BEH/IAQ staff noted hand sanitizers, cleaning products, and dry erase materials in some areas (Picture 12; Table 1). All of these products have the potential to be irritants to the eyes, nose, throat, and respiratory system of sensitive individuals. Scented products such as air fresheners should not be used in schools, as many people are sensitive to the chemical compounds used in them. Consult the document "[Clean Air Is Odor Free](#)" for more information on use of scented products. While hand sanitizers may be necessary, these should be used in areas with good ventilation, with the containers kept closed when not in use.

**Cleaning products and sanitizers in a classroom**

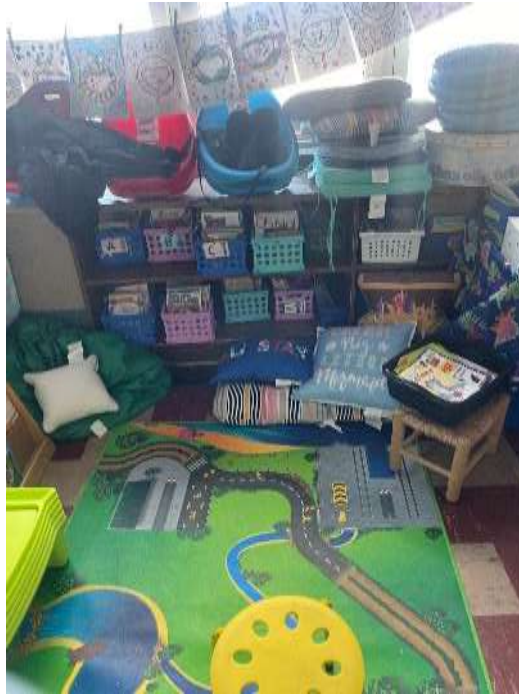
**Picture 13**

Items were noted on surfaces in classrooms, including floors and univents (Picture 13). Items stored in classrooms, offices and storerooms provide a source for dusts to accumulate and make it difficult for custodial staff to clean. Items should be stored neatly and sorted frequently to remove items that are no longer needed.

Many classrooms had area rugs (Picture 13; Table 1). Facility staff reported that these are all purchased new for the school and kept off the floor during the summer. Carpets and area rugs should be vacuumed regularly with a high efficiency particulate arrestance (HEPA)-filter-equipped vacuum cleaner and cleaned annually (or semi-annually in soiled/high traffic areas) in accordance with Institute of Inspection, Cleaning and Restoration Certification (IICRC) recommendations (IICRC, 2012). Second-hand area rugs should not be used in classrooms, as they may bring allergens such as pet hair into the school.

**Items in a classroom including area rugs**

24. Store items neatly and off the floor to assist with cleaning.
25. Avoid hanging items from the ceiling.
26. Keep food stored in tightly closed pest-proof containers.

27. Keep food preparation equipment clean.
28. Clean area rugs and carpets in accordance with IIRC recommendations. Store area rugs rolled up and off the floor in a dry area during summer break.
